SAFETY ALERT

No: SA 2016.02

Date: 26 May 2016

Subject: MTO3 and MTO Sport Main Undercarriage

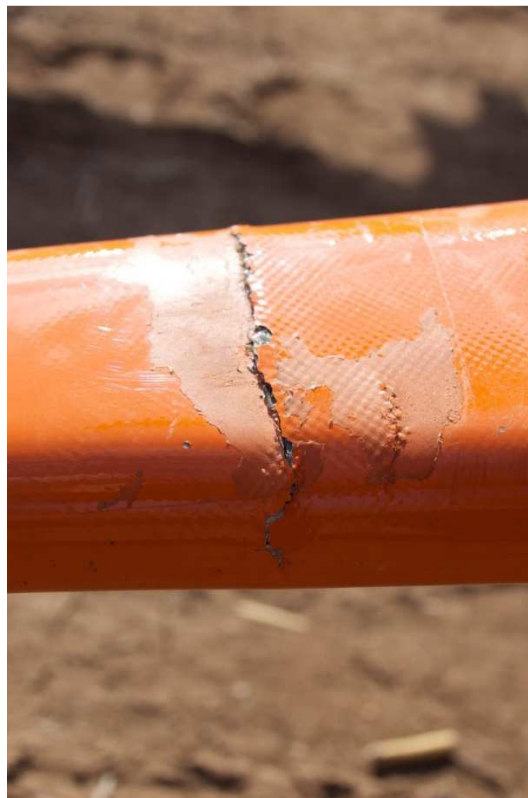
The failures manifested themselves through the appearance of cracks that appeared from beneath the non-slip footsteps on one side of the undercarriage. In both cases, the cracks initiated from under the footsteps and were not visible until they had progressed through approximately 50% of the surface of the undercarriage.

In both cases, the non-slip material was wrapped around the leg such that the cracks were not visible until they had progressed to a point where they were not hidden by the non-slip material.

ALERT: ASRA strongly recommends that the owners, operators and pilots of MTO3 and MTO Sport gyroplanes pay particular attention to the undercarriage legs in the vicinity of the non-slip footsteps with a view to detecting cracks before they progress to the point of catastrophic failure.

Furthermore, consideration should be given to removing any non-slip material and reducing its area such that it does not wrap around the upper edges of the undercarriage legs thus allowing even earlier detection of cracks. In this case, guidance should be sought from the manufacturer or the manufacturer's Australian agent to determine how to safely remove the non-slip material without damaging the composite legs.
