AUSTRALIAN SPORT ROTORCRAFT ASSOCIATION INC

AIRWORTHINESS DIRECTIVE

No. AD 2005.01 (originally AD 05/2005)
Date: 20 August 2005
Subject: Gyroplane Hub-bars

BOLT HOLE AND SURFACE SCAN EDDY CURRENT INSPECTION OF THE ROTOR HUB ATTACHMENT BAR

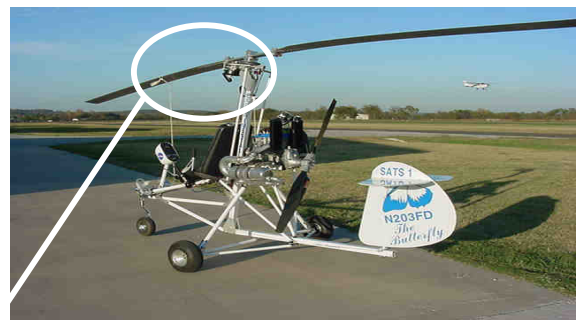
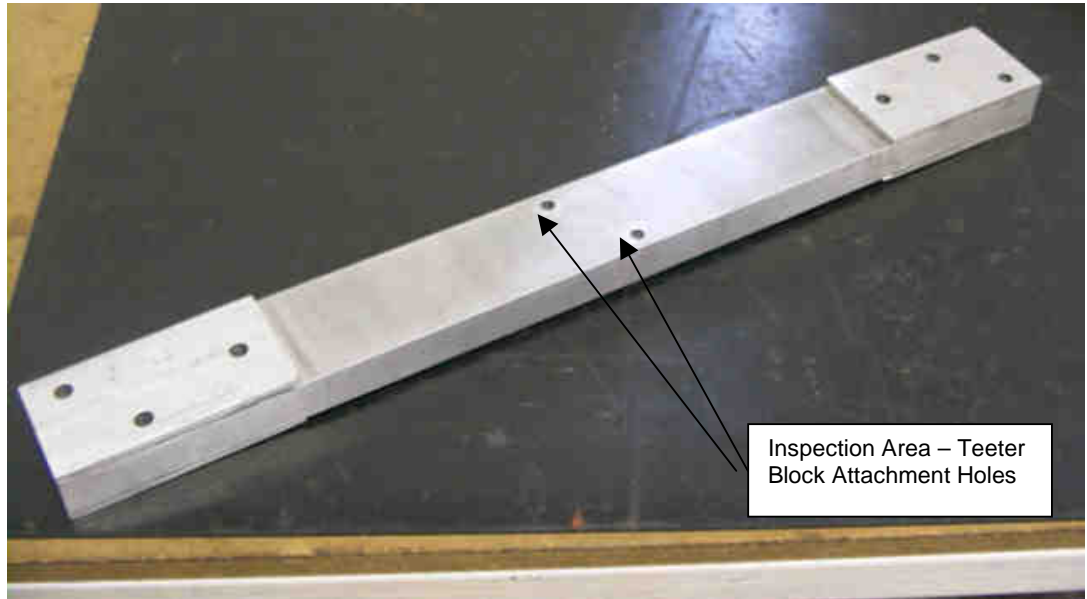
Figure 1: Location of Teeter Block Attachment Holes

101. Recently, an aircraft suffered a catastrophic blade separation during a go-around manoeuvre, which resulted in the total loss of the aircraft and injuries to both crew. Investigations revealed that the Hub Bar failed from a bolt hole that attaches the hub bar to rotor head via a teeter block assembly.
102. The hub bar that failed was manufactured from 6061 T6 aluminium alloy. The failure initiation appeared to originate in a teeter block attachment bolt hole. Catastrophic failure occurred when the defect reached approximately 12mm in length. The defect would not have been visible during pre-flight inspections as propagation was under the teeter block. Figure 1 details the inspection area.
