# AUSTRALIAN SPORT ROTORCRAFT ASSOCIATION INC

## AIRWORTHINESS DIRECTIVE

**No.** 01/2004  
**Date:** Thursday, 21 October 2004  
**Subject:** Larkin Hub-bars

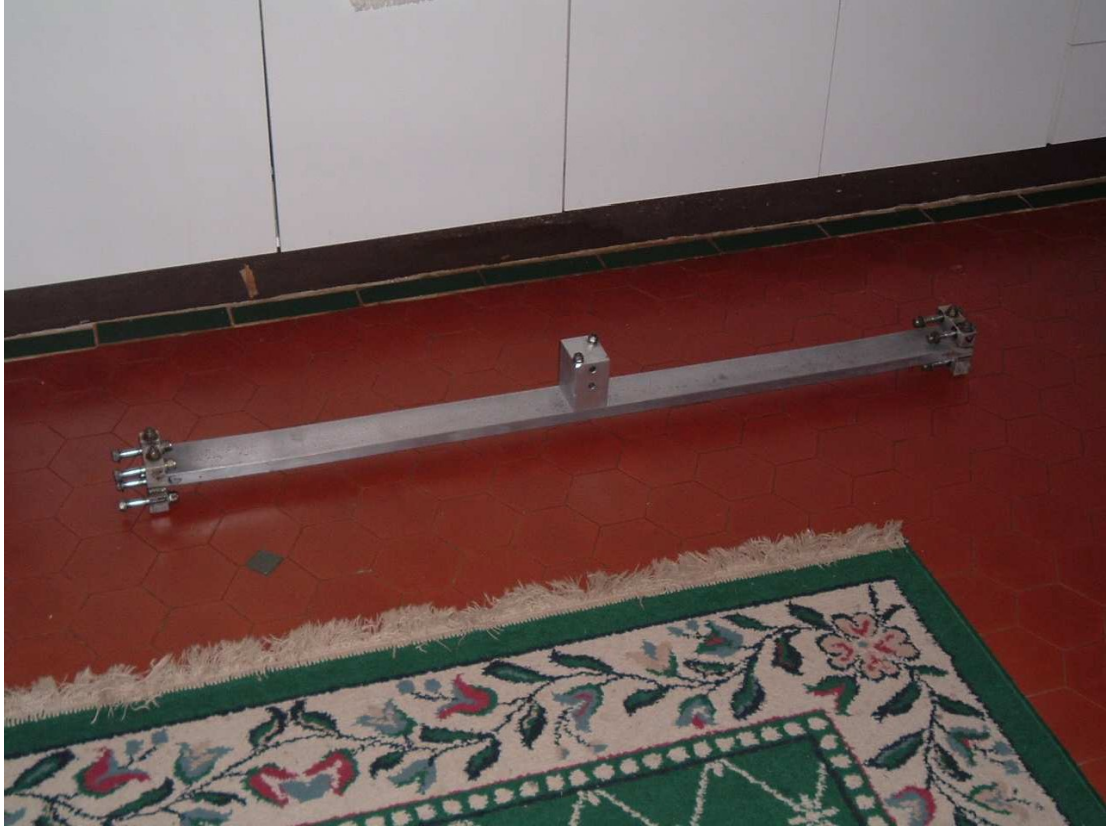
Larkin hub-bars are manufactured from aircraft grade 2024 T3 aluminum which, although stronger than 6061 T6 is more brittle and is affected by corrosion to a greater degree. They may be identified by serial numbers that have a format similar to "123 + 8L". A photograph is attached to assist with identification.

All gyroplanes registered with or operated by ASRA members that are fitted with Larkin blades are grounded forthwith.

These gyroplanes must not be flown until the Larkin hub-bar is replaced and the modification is inspected and approved by a suitably qualified ASRA Technical Adviser.
