# AUSTRALIAN SPORT ROTORCRAFT ASSOCIATION INC

## AIRWORTHINESS DIRECTIVE

**No.** 2008.01  
**Date:** 1 May 2008  
**Date reviewed:** 23 Jan 2025  
**Subject:** Gyroplane Hub-bars

## **BOLT HOLE AND SURFACE SCAN EDDY CURRENT INSPECTION OF THE ROTOR HUB ATTACHMENT BAR**

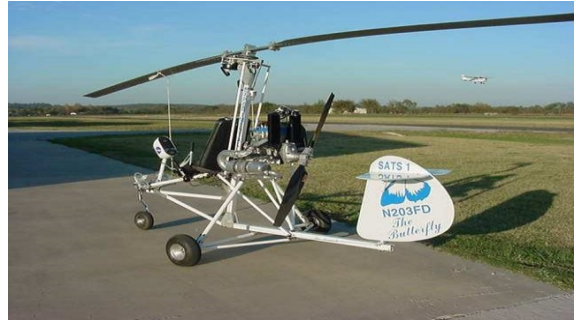
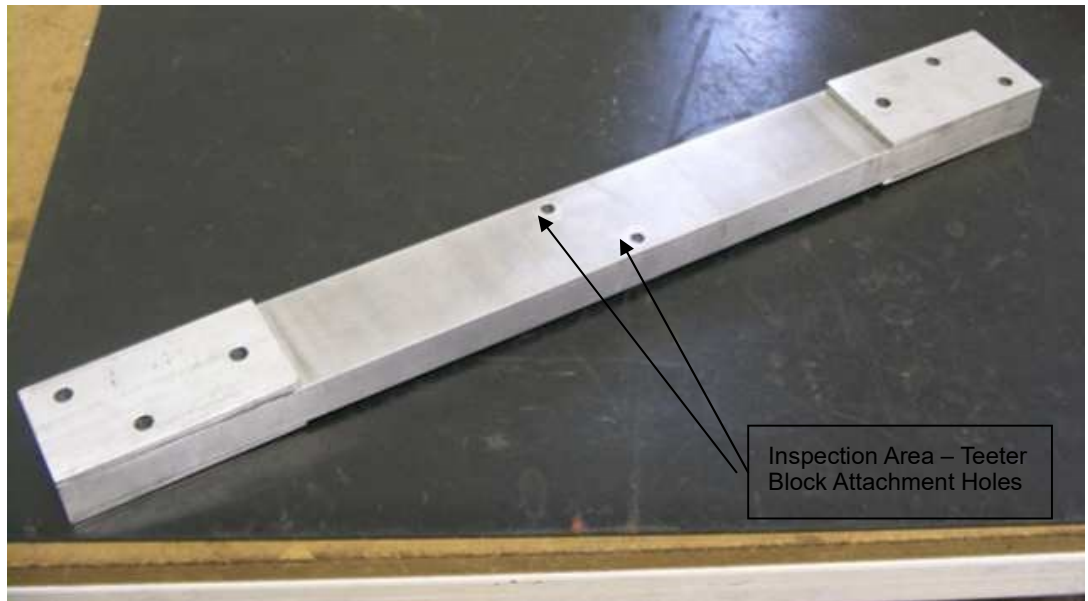
**Figure 1:** Location of Teeter Block Attachment Holes

101. Recently, an aircraft suffered a catastrophic blade separation during a go-around manoeuvre, which resulted in the total loss of the aircraft and injuries to both crew. Investigations revealed that the Hub Bar failed from a bolt hole that attaches the hub bar to rotor head via a teeter block assembly.
102. The hub bar that failed was manufactured from 6061 T6 aluminium alloy. The failure initiation appeared to originate in a teeter block attachment bolt hole. Catastrophic failure occurred when the defect reached approximately 12mm in length. The defect would not have been visible during pre-flight inspections as propagation was under the teeter block. Figure 1 details the inspection area.

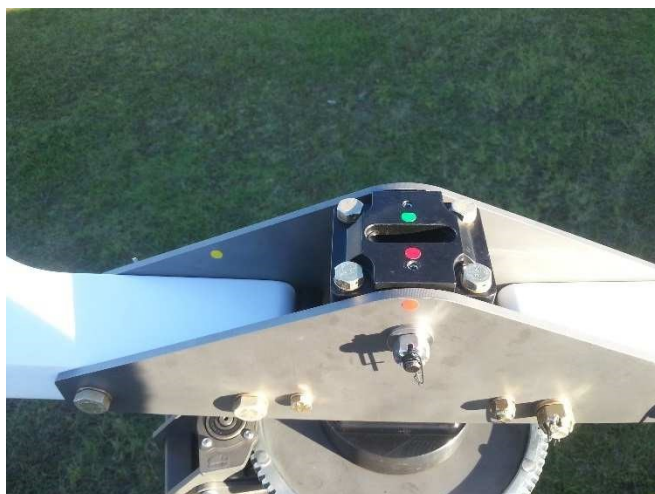
Extensive research has revealed that there have been no known failures or defects detected in the hub-bars currently fitted to these gyroplanes most likely indicating that the "side plate" design (photo below) is not prone to the fairly predictable onset of cracking and very occasional catastrophic separation known to occur in conventional aluminium hub bars substantially exceeding 1000 hours time in service. Additionally, the eddy current testing process described within the AD is only relevant for deep holes in thick metals.

**Dispensation.** Gyroplanes manufactured by Magni Gyro Company and TAG Aviation that utilise the hub-bar design pictured above are exempted from the requirements of ASRA AD 2008.01. Testing and life of these hub-bars is as per manufacturer's recommendations or requirements. This dispensation is only applicable to hub-bar designs similar to that pictured.
