Title: Calidus airframe inspection		
AG-SIL-2019-01-B-EN		Compliance Category:
Applicability		A – MANDATORY
Aircraft type & model: All AutoGyro Calidus	Affected aircraft serial numbers: All AutoGyro Calidus	B – RECOMMENDED
		C – OPTIONAL
The maintenance manual to be referenced is this stated or subsequent issue.		As per AutoGyro website
<p>This form is the response from AutoGyro GmbH either against a problem found in the product in service requiring a containment or rectification action, or as service information for aircraft modification incorporation. For help, contact AutoGyro on 49(0)5121 88056-00, or email airworthiness@auto-gyro.com.</p>

Reason and overview of the Service Information Letter (cause of problem if known)

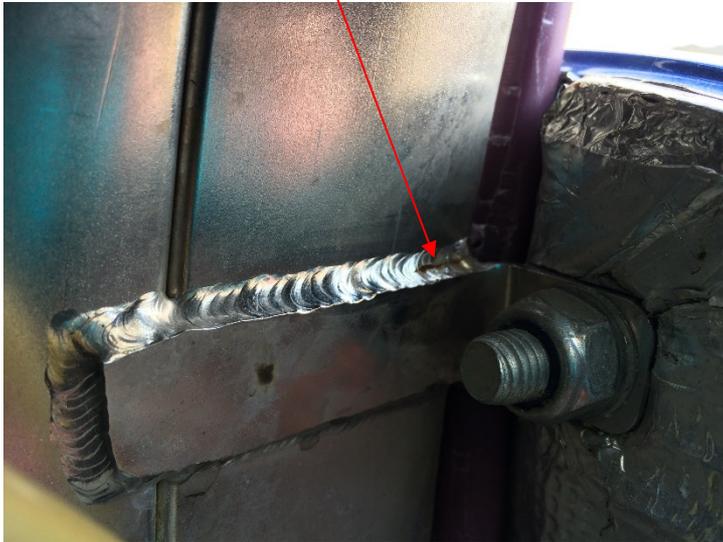
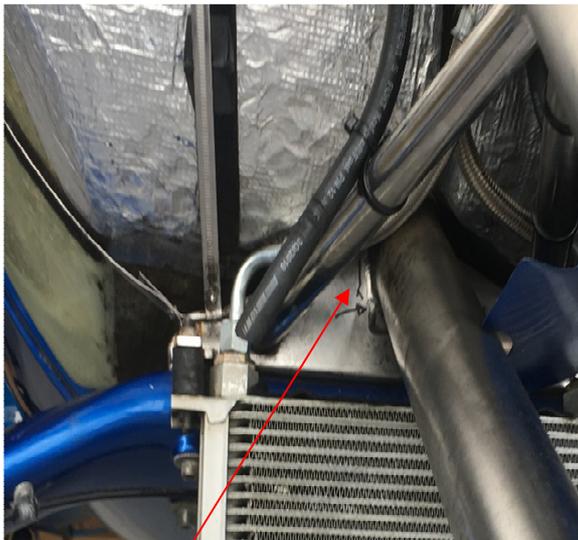
These aircraft have now accumulated many years and hours in service, resulting in service issue reports submitted to AutoGyro. Within these AutoGyro has been advised of cracks in the suspension bow mounting bracket attachment to the mast tubes, and in the front edge of the folded bracket itself. Cracks have also been found in the upper body mounting bracket weld.

Check in right-hand upper body bracket weld

The issues are not safety critical, and are resolved by the application of the appropriate Service Repair SAR-020 (body bracket), 023 and 024. They are also long term fatigue based, dependent on operational usage, and controlled by the 100hr service inspection interval.

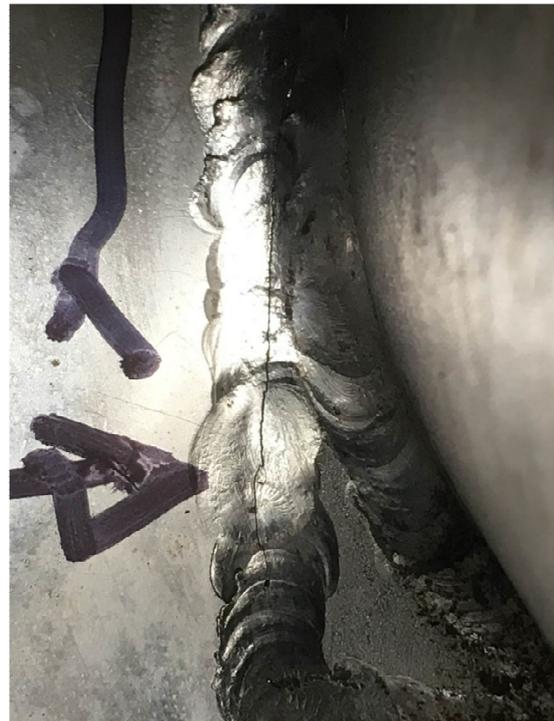
Crack position (could be either side of the mast) between the rear bracket and the mast/keel tube

However, failure to find such issues could - especially in the suspension mounting bracket area - lead to subsequent significant bracket distortion and major repair work. SRA-025 covers the replacement of the entire suspension bow mounting bracket, a task that takes many days.

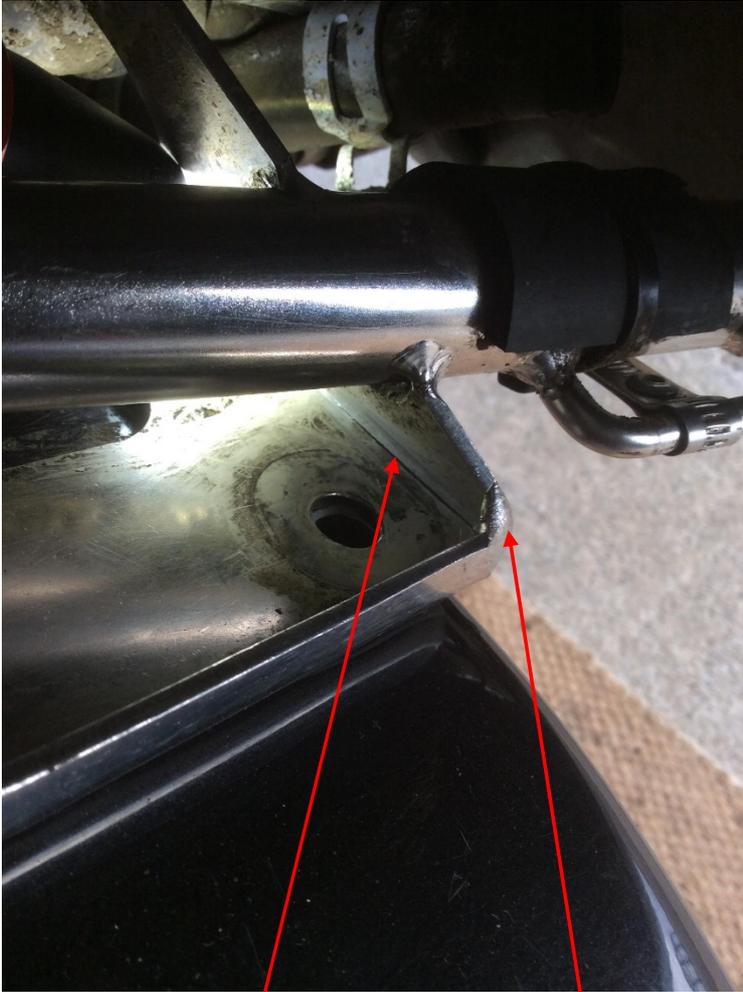
View of crack in the leading edge of the folded bracket area. This is visible from outside front of the bracket. Also check the corner bracket weld
