AUSTRALIAN SPORT ROTORCRAFT ASSOCIATION INC

SAFETY ALERT

No: 2019.02

Subject: Liberty Sky stone guards

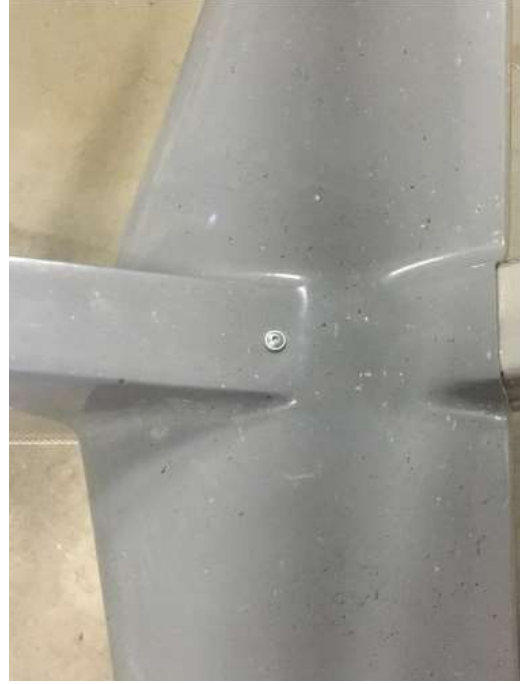
The owner of an Autogyro MTO found it necessary to replace the stone guard on his Gyroplane. The replacement was supplied and fitted by Liberty Sky in Australia. The fitting used a single screw and ordinary washers in lieu of the two screws and large flat washers used by the OEM. Having been fitted at Autogyro Australia, he assumed that it was approved for use.

During flight, the stone guard detached and travelled into the propeller causing two blade tips to fail and damage the remaining blade. Part of a propeller then travelled up into the rotor disc damaging one rotor blade. A successful idle power landing ensued.

The damaged stone guard was recovered and when the owner attempted to refit it, he noticed that the single retaining nut (rivnut or similar) appeared to be stripped, as he was unable to tighten the screw. He had not removed the stone guard since it was fitted.

The owners, operators and pilots of Autogyro gyroplanes that utilise this type of stone guard are strongly advised to discard any stone guards that use only one mounting screw and replace them with a genuine Autogyro factory product that is attached using two screws and large flat washers. Alternatively, owners should contact Liberty Sky regarding the required modifications to the method of attachment.
