SAFETY ALERT

No: SA 2021.03

Subject: ELA 10-Eclipse leaking fuel tanks

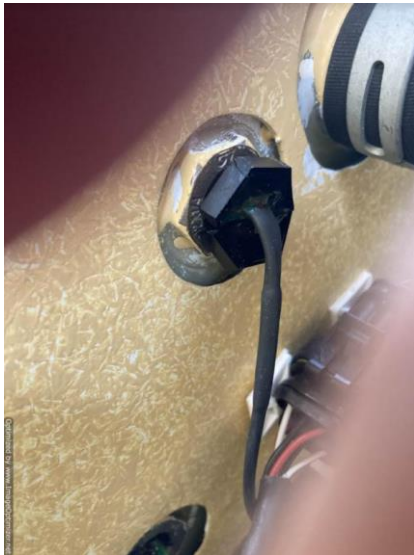
- Model affected: ELA 10-Eclipse
- Year of manufacture: from approximately 2018 – this is the model with the **optical fuel sensor**, not the float type. Refer to the attached photograph.

- Symptoms: Opening the canopy you can smell fuel as if it has been leaking into the cabin. The optical fuel sensors are a tapered thread into a metal insert which is bonded to the fuel tank. The sensor is enclosed in a plastic threaded plug. It appears that only the optical sensor part is exposed to the fuel in the tank.

- Fuel is leaking between the outside of the metal insert and to the outside of the tank, which then allows it to “attack” the plastic surrounding the optical sensor. This causes the plastic around the sensor to deteriorate to the point where the sensor may stop working. Fuel will continue to leak slowly into the cabin – it may only be evident by smell, or as it worsens you may find fuel pooling in the bottom of the cabin and leaking onto the floor. There are four sensors in total and the most affected ones appear to be the 10l and 25l sensors under the rear seat, however the 45l and 65l sensors have also been affected.

- Current resolution: if you attempt to unscrew the plastic plugs they will fall apart. Advice from ELA is they need to be drilled out carefully, without damaging the thread of the metal insert. Replace with either replacement fuel sensors (if ELA have sent them) or NPT 1/4" tapered brass plugs with Loctite 567. Note that fuel will still be leaking past the outside of the metal insert. The recommended next step to address this leaking area is to enlarge the hole in the fairing (where sensors are installed) to 40mm, sand the surface of the tank in the vicinity of the fitting with 60 grit sandpaper, mix Caswell Epoxy gas tank sealer with hydrophilic fumed silica to a thick homogenous mixture and apply to prepared area. Allow it to cure for 24 hours before refilling the tank and checking for further leaks. The tank should also be flushed to remove any debris which has fallen into it.
