## Autogyro MTO Sport - the importance of performing maintenance inspections

### SAFETY ALERT

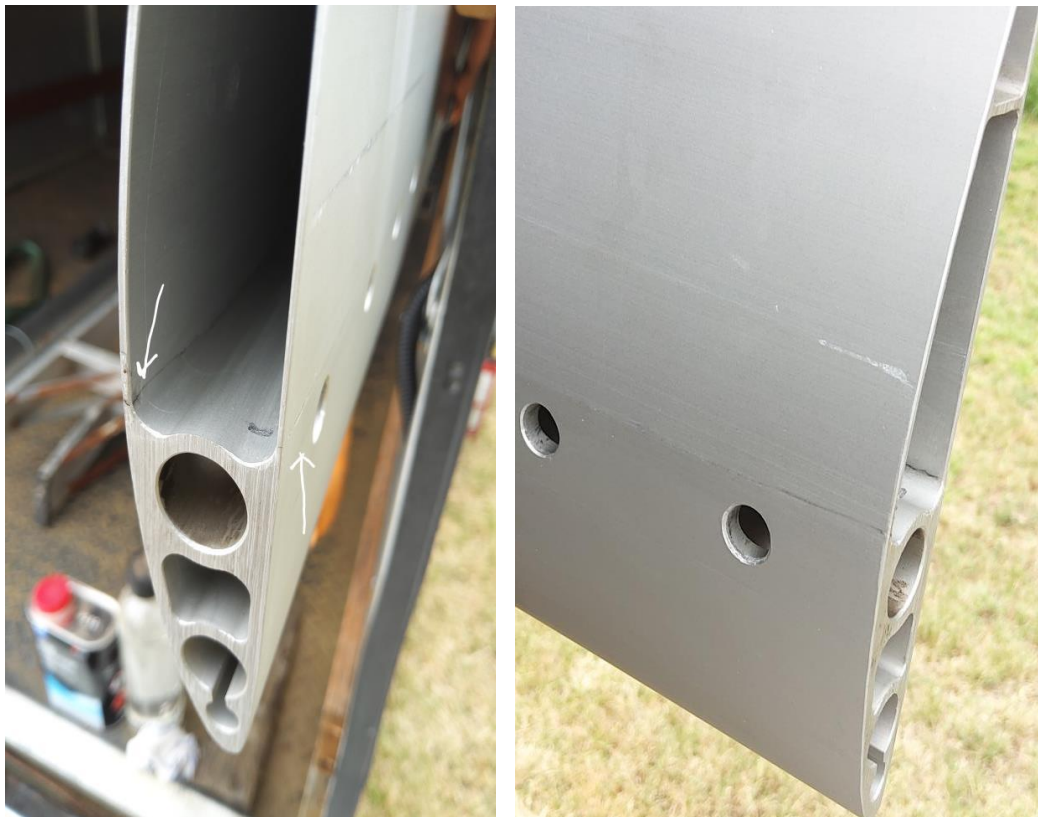
During a scheduled maintenance inspection a hairline fracture was discovered in the root of an Autogyro rotor blade. The fracture is approximately 50mm long and runs parallel with the internal spar of the rotor blade and is visible on the upper and underside of the blade.

The fracture does not appear to emanate or terminate at a blade bolt hole. As the fracture was covered by the hub bar strap Autogyro can only emphasise the importance of their periodic inspection protocol.

**“Most likely cause is rough field operations, possibly with a tight tie-down. It is taxi induced damage, not flight damage”.**

This analysis is consistent with the type and locations in which the gyro has operated from for many years. Minor contact with a tree prior to the fracture being discovered may have also contributed to the damaged blade.
