ASRA Safety Alert SA 2024.01

Subject: ELA 07 Cougar cracks in the rotor brake/ trim assembly

Aircraft Type: ELA07-Cougar

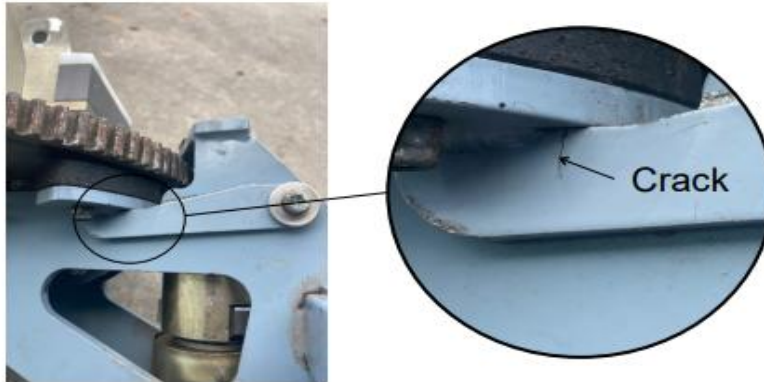
Aircraft has 800hrs operation and during a routine pre-flight inspection the following cracks were observed in the rotor-brake / trim assembly. Due to the nature of the offset crank for trim control a failure in flight of this part could, potentially, result in the rotor brake jamming between the rotor head and the pre-rotator ring gear.

Before next flight, inspect closely for any signs of cracks. Add this point to all pre-flight inspections as exact time of cracks developing is unknown.
