ASRA Airworthiness Directive SD 2024.01

January 9th, 2024

Subject: Sportcopter M912 Heavy Duty Hub Bar with adjustable pitch

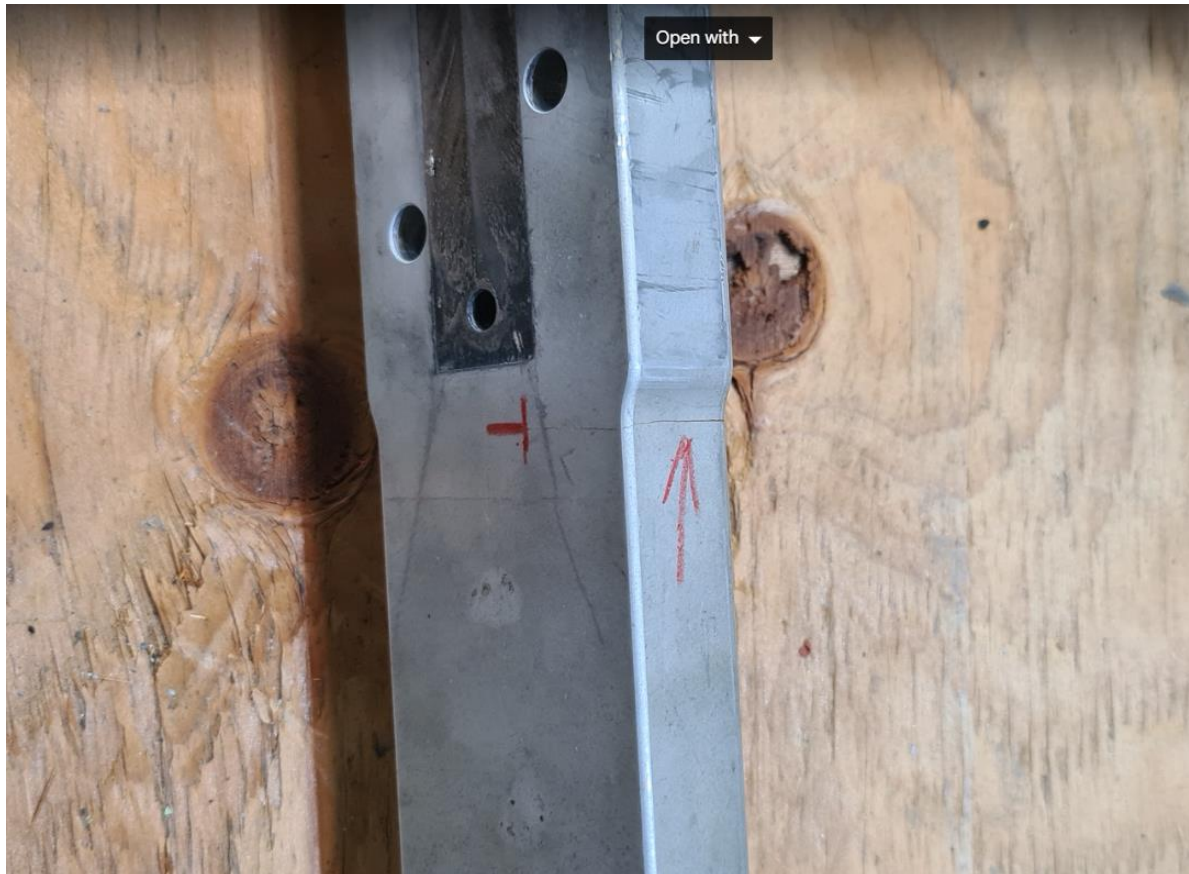
One Sportcopter Heavy Duty Hub Bar, fitted to M912 models, has been found to have a crack near the root of the hub bar, aligning approximately with the teeter bump stop on one side. The aircraft has been subject to regular high energy manoeuvres and high RPM pre-rotator take-offs for the life of the hub bar for over 1,000 hours.

Refer to Photo 1 below, showing the location of the cracks in the hub bar.

Photo 1. Crack location in Sportcopter adjustable pitch heavy duty hub bar.

1. With immediate effect and until this SD 2024.01 is superseded, all Sportcopter Heavy Duty Hub Bars with adjustable pitch are subject to the existing ASRA AD 2008.1. The ASRA exemption given for Sportcopter adjustable pitch hub bars is revoked until further notice.
2. A safety inspection of this hub bar is required to be performed prior to the next flight in conjunction with any requirements of ASRA AD 2008.1
