# AUSTRALIAN SPORT ROTORCRAFT ASSOCIATION INC

## AIRWORTHINESS DIRECTIVE

**No. 2008.01**

**Subject:** Gyroplane hub bars

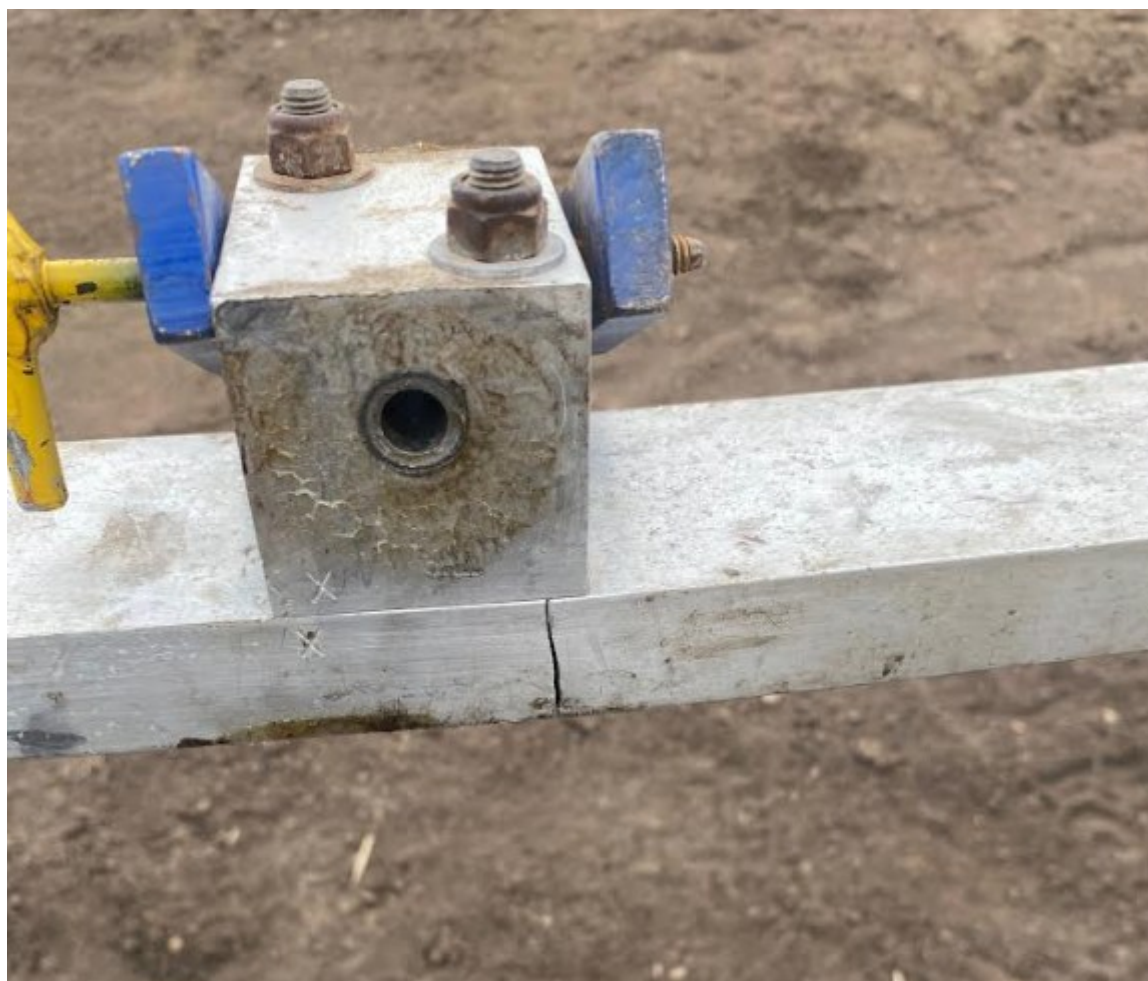
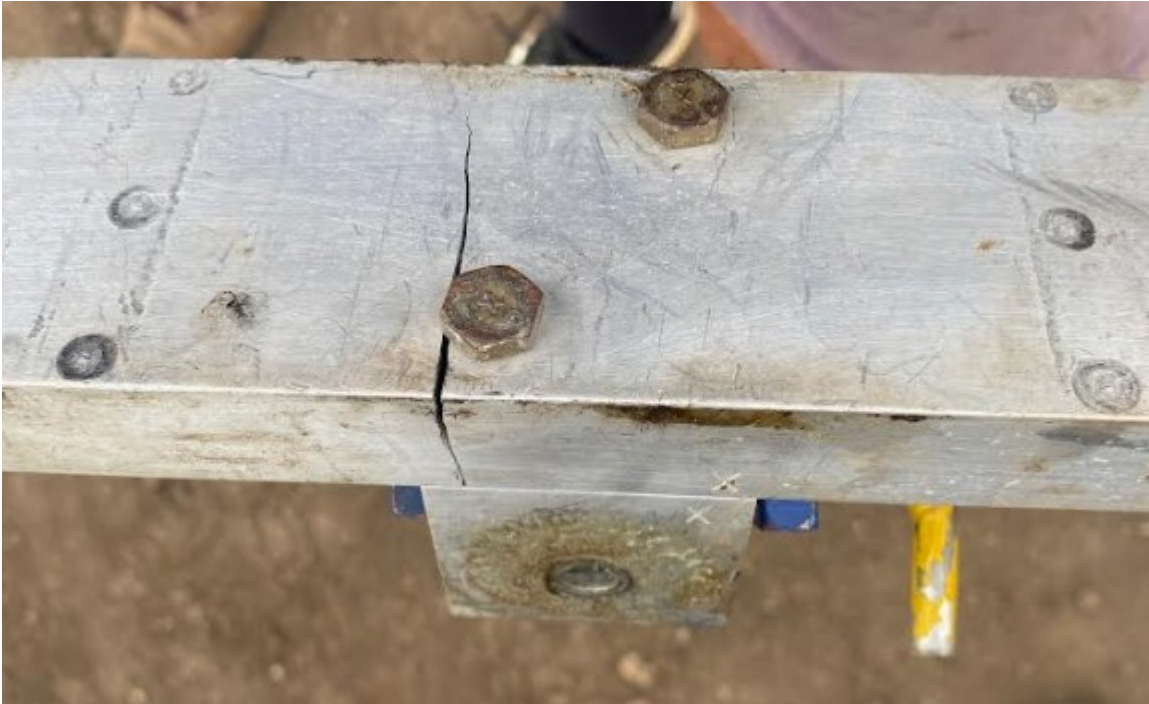
This Airworthiness Directive AD 2008.01 review follows an emergency landing completed in June 2026. The pilot experienced the onset of significant and abnormal stick shake, then cabin shake during a local flight. The pilot made a good decision to land asap on a farm dirt access road. The following photographs clearly show that the remaining service life of the hub bar was likely measured in minutes. The estimated total time in service for this hub bar was 1100 hours.

In cases where the hub bar total time in service (TTIS) or hub bar service history is unknown for a gyroplane, it is recommended to replace the hub bar. As a minimum, immediately complete NDT to establish a new reference baseline and commence 100 hourly NDT inspections.

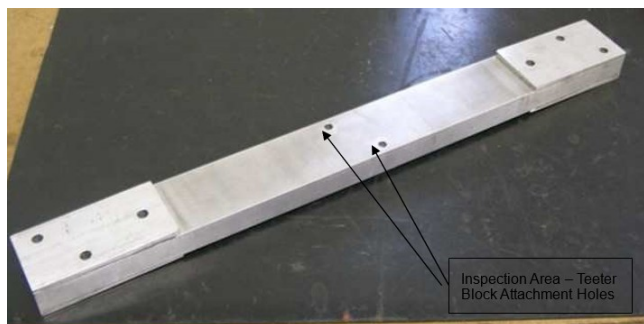
**Figure 1:** Location of Teeter Block Attachment Holes

101. Recently, an aircraft suffered a catastrophic blade separation during a go-around manoeuvre, which resulted in the total loss of the aircraft and injuries to both crew. Investigations revealed that the hub bar failed from a bolt hole that attaches the hub bar to rotor head via a teeter block assembly.
102. The hub bar that failed was manufactured from 6061 T6 aluminium alloy. The failure initiation appeared to originate in a teeter block attachment bolt hole. Catastrophic failure occurred when the defect reached approximately 12 mm in length. The defect would not have been visible during pre-flight inspections as propagation was under the teeter block. Figure 1 details the inspection area.

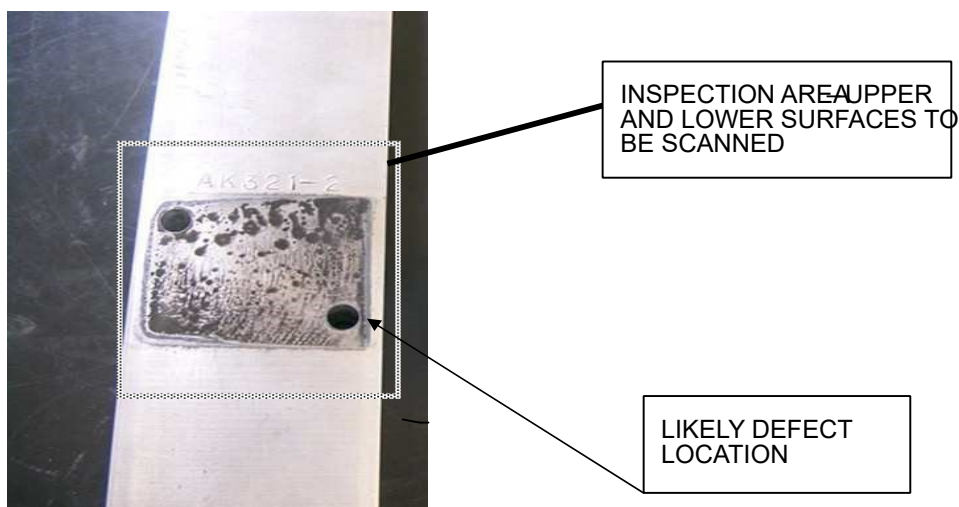
**Figure 3: Hub Bar Showing Possible Defect Location and Scan Areas**

- (a) Place the probe on the inspection surface approximately 2 mm from the edge of a teeter block attachment hole
- (b) Balance the instrument and check the lift off response
- (c) Adjust the phase angle (if required) to achieve a lift off response as shown in figure 2
- (d) Scan around both bolt holes on the upper and lower surfaces of the hub-bar.
- (e) Scan the upper and lower surfaces in an area that will cover 10 mm further outboard than the extremity of where the teeter block mounts. Inspection area shown in Figure 3.
- (f) Mark any repeatable defect indications that cannot be attributed to edge effect or lift-off.

112. Any repeatable defect indication that cannot be attributed to lift off or part geometry is cause for the hub bar to be placed unserviceable.

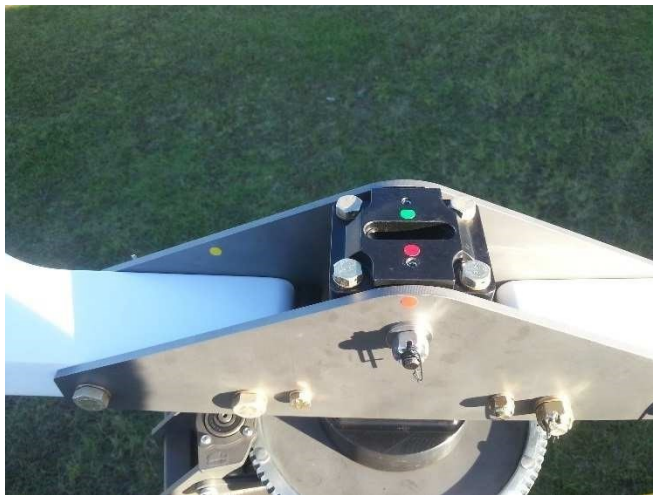
Extensive research has revealed that there have been no known failures or defects detected in the hub-bars currently fitted to these gyroplanes most likely indicating that the "side plate" design (photo below) is not prone to the fairly predictable onset of cracking and very occasional catastrophic separation known to occur in conventional aluminium hub bars substantially exceeding 1000 hours time in service. Additionally, the eddy current testing process described within the AD is only relevant for deep holes in thick metals.

**Dispensation.** Gyroplanes manufactured by Magni Gyro Company and TAG Aviation that utilise the hub bar design pictured above are exempted from the requirements of ASRA AD 2008.01. Testing and life of these hub bars is as per manufacturer's recommendations or requirements. This dispensation is only applicable to hub bar designs similar to that pictured.
