## SAFETY ALERT

No: SA 2021.02

Subject: Magni Gyro airframe corrosion

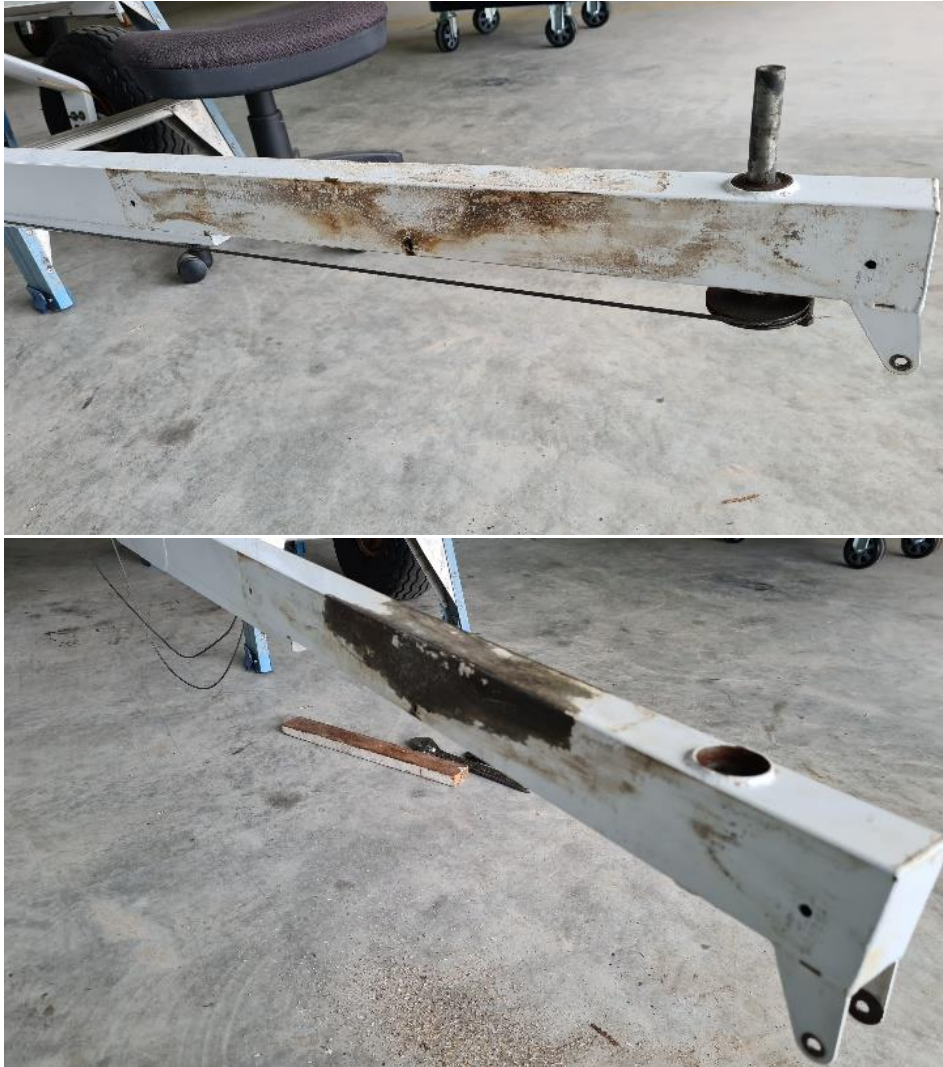
A small spot of surface rust was noticed on the keel under the tail. The tail was removed to allow an inspection for any further corrosion.

Surface rust was found to be extensive under the tail and the rudder bearings were also affected.

ASRA recommends that owners, operators and maintenance personnel of all Magni Gyro's pay particular attention to the airframe for corrosion in areas that are hidden/covered or where water/moisture can be retained.

It would be prudent to remove the rudder after 500hrs or 5 years.  
Rudder bearings should also be replaced if they show signs of corrosion or stiff/rough movement.

An inquiry with photos was sent to Magni Gyro who confirmed that the corrosion was only superficial. They recommended repair following normal automotive painting procedures and products.
