# AUSTRALIAN SPORT ROTORCRAFT ASSOCIATION INC

## AIRWORTHINESS DIRECTIVE

**No.** 2008.01  
**Date:** 1 May 2008  
**Date reviewed:** 23 Jan 2025  
**Subject:** Gyroplane Hub-bars

## **BOLT HOLE AND SURFACE SCAN EDDY CURRENT INSPECTION OF THE ROTOR HUB ATTACHMENT BAR**

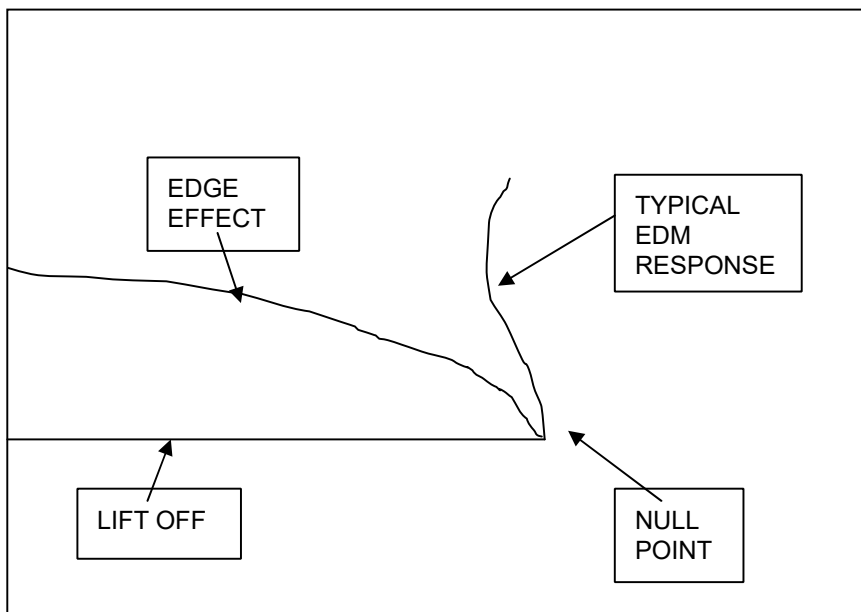
**Figure 2: Eddy Current Instrument Screen Set-up**

108. Calibrate the instrument utilising the manufacturer's handbook to represent an 80% of full screen height (FSH) response (null point represents 0% FSH) from the 0.5mm deep EDM slot. Figure 2 depicts a typical screen response.

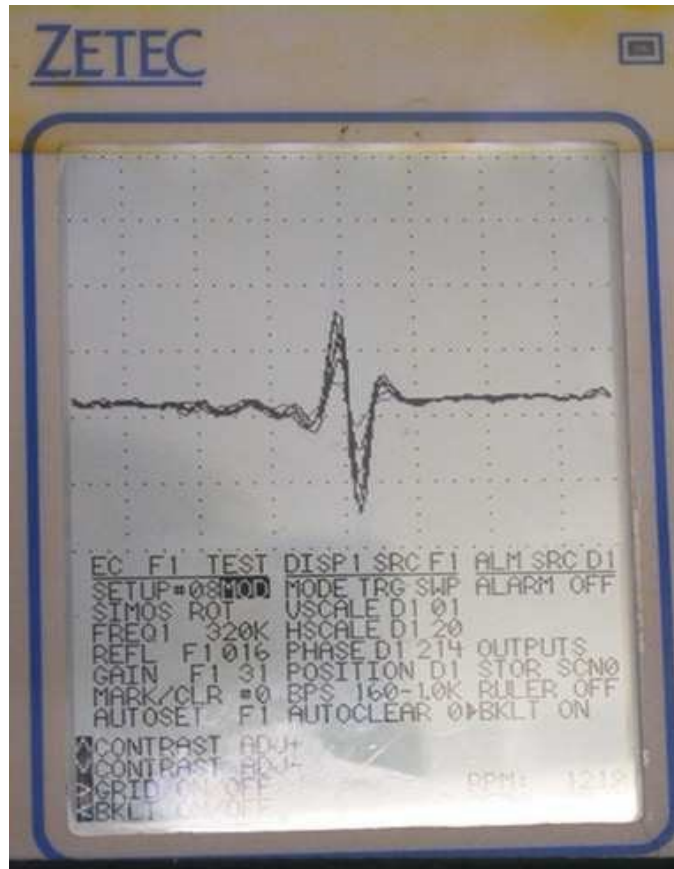
Figure 4: Typical Screen Response for Bolt Hole Inspection

- 110. Calibrate the instrument utilising the manufacturer’s handbook to represent an 80% of full screen height (FSH) response from the 1mm cross-drilled hole in the reference standard. Figure 4 depicts a typical screen response.

112. Any repeatable defect indication that cannot be attributed to lift off or part geometry is cause for the Hub Bar to be placed unserviceable.
