TAG AVIATION PTY LTD

SAFETY ALERT: SA No. 2020.03

Subject: TAG Aviation airframe weld failure.

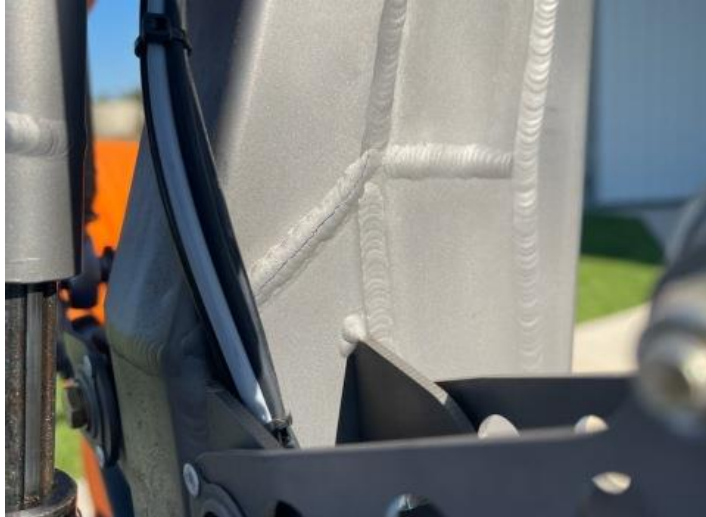
The owner of a Titanium Explorer gyroplane reported finding a cracked weld in the mast of his gyro during a routine pre-flight inspection. An investigation has been carried out by TAG Aviation to determine the cause of this crack. It appears the weld was under stress.

For quality control purposes, TAG had identified 3 masts during production that required an increase to the weld thickness of the rear butt joints as pictured. The re-welded masts were consequently required to be heat treated again prior to delivery.

Internal investigation confirmed that the 3 re-welded masts (includes the mast pictured), were not subject to the second heat treatment.

TAG will remove the masts from the 3 affected gyroplanes and have them repaired and heat treated before returning them to service. The airframe serial numbers are 0060-0320, 0058-0120, 0059-0120. Owners have been advised. TAG has also addressed the internal communication matter.

Owners, operators, and pilots of all types of gyroplanes that utilise welded airframes are advised to pay particular attention to the airframes in the vicinity of welded joints during pre-flight inspections and regularly during daily operations and maintenance for indications of airframe cracking.
